# Welwyn Village Conservation Area Character Appraisal and Management Plan

Client:  
Welwyn Hatfield Borough Council

Date:  
August 2022

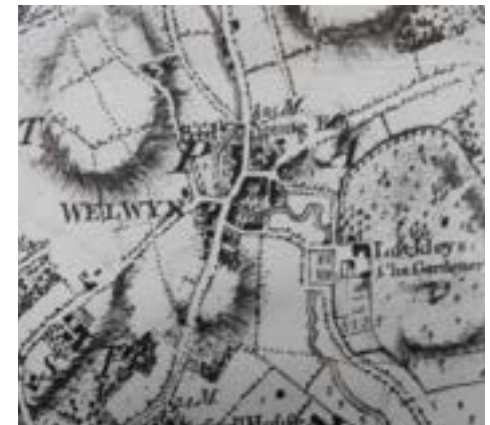
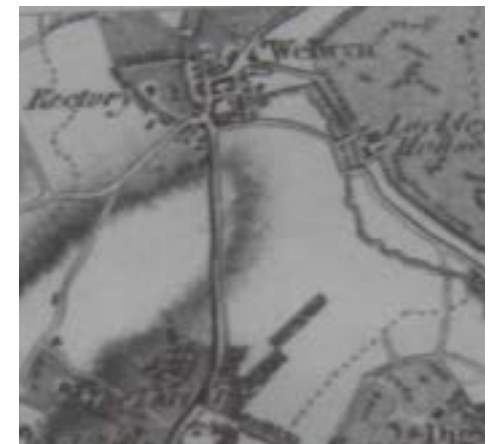
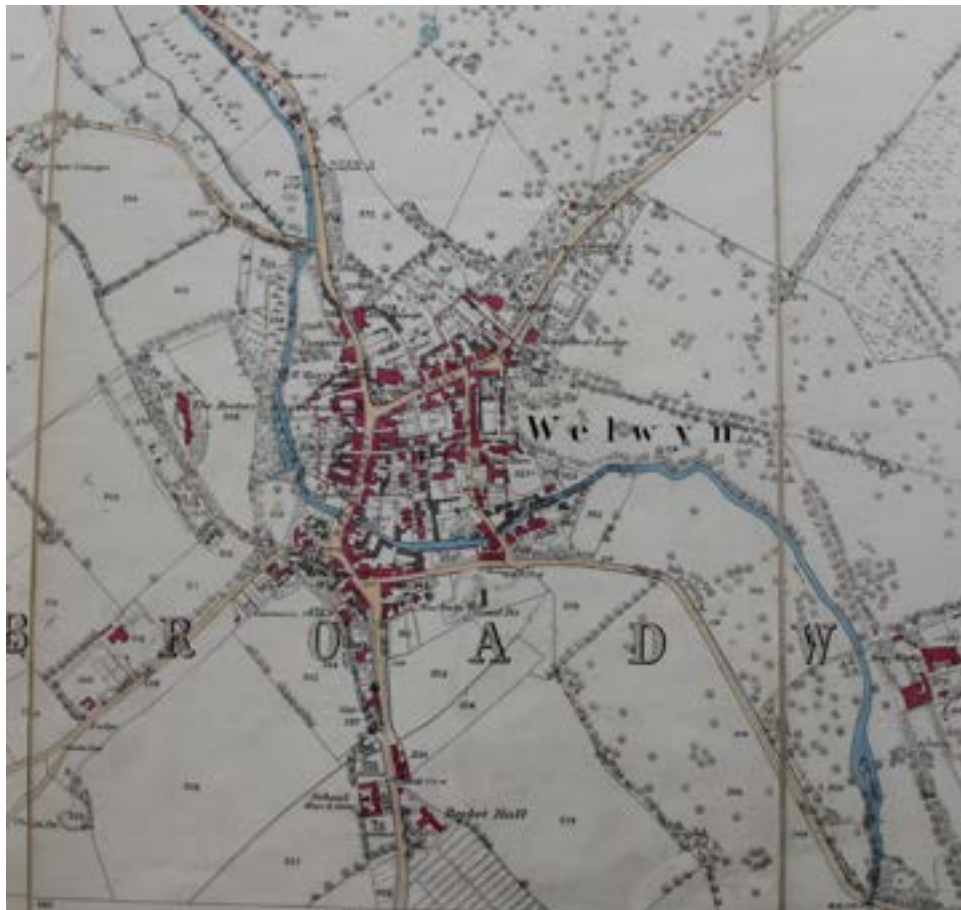
The Drury and Andrews 1766 Map (Figure 3), Bryant's Map of Hertfordshire 1822 (Figure 4) and the first edition Ordnance Survey Map 1881 (Figure 5) demonstrate the compact development of the village, with Lockley Park bounding it to the east and the Rectory to the west. Bryant's Map and the 1881 OS Map also highlight the introduction of the eighteenth-century Danesbury Park to the north. While there was no outward expansion at this time, as indicated on these maps, there is evidence that development occurred within the village core. In the early nineteenth century housing density was fairly

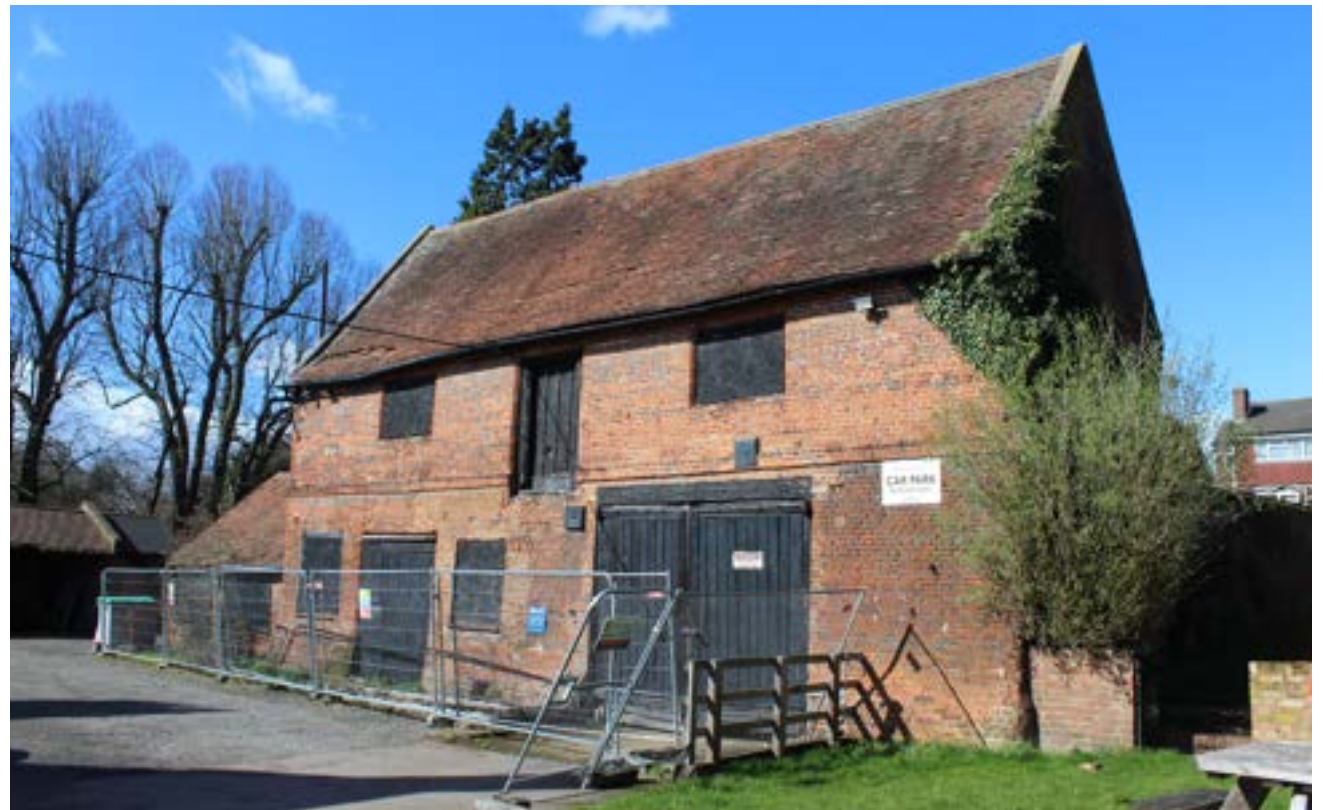
Figure 10 South elevation of the Former Coach House on the North Side of The Rose and Crown

The grade II Listed Rose and Crown Public House, Former Coach House on North Side of Car Park (List Entry No. 1100957) is currently at risk of deterioration (Figure 10). This seventeenth century former coach house is in a poor state of repair, and works are required to maintain the building and find a continued use for it; it is currently vacant, so at risk of further deterioration.

The Rose and Crown Public House is a timber framed seventeenth century structure with roughcast render and a steeply pitched plain tile roof (List Entry No. 1348199). The former coach house, now storehouse, sits behind the Rose and Crown and this again dates to the seventeenth century and is likely contemporary (List Entry No. 1100957). It comprises a rectangular two storey structure of red brick with parapet gable ends and a first floor band. This structure is currently in a poor state of repair, as highlighted in section 2.8.

It is considered that, in its current condition, the grade II listed former coach house on the north side of the car park at the Rose and Crown (Listed Entry No. 1100957), detracts somewhat from the public house complex. This would be easily rectified with some maintenance work to the building.

There is also opportunity for improvement to the grade II listed former coach house within the curtilage of The Rose and Crown due to its current state of repair.

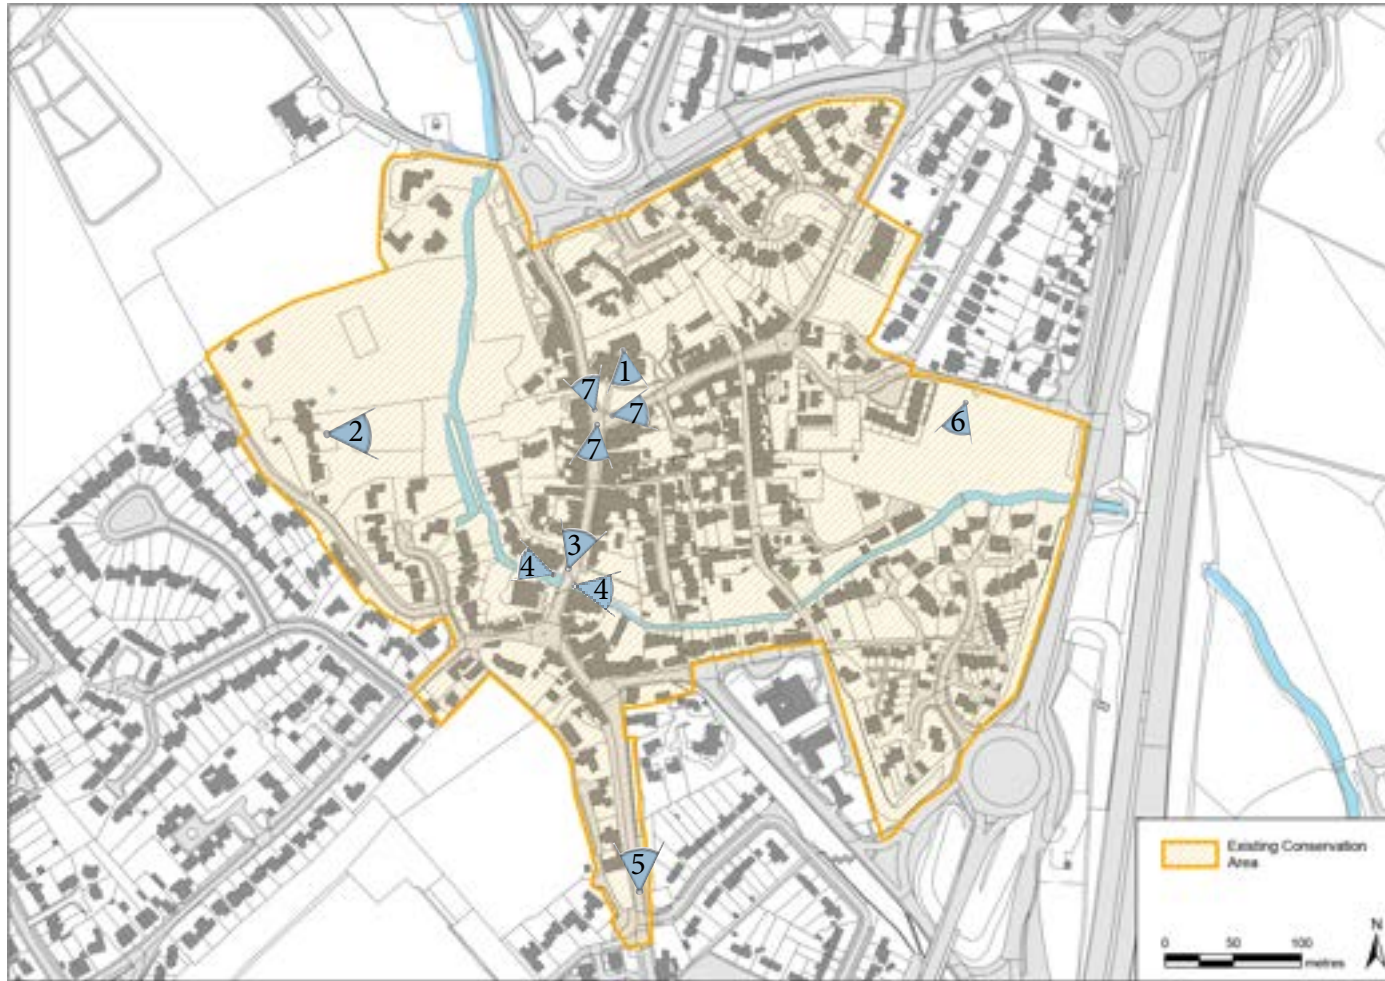
Figure 12 Views Map

Key views are identified on Figure 12. Note the views included are a selection of key views; this list is not exhaustive and there are numerous other views of significance. Any proposals for development within the conservation area, or its environs, should consider the views below and any others which may be relevant or bespoke to that proposal. It is also notable how these views alter in character between winter and summer months which must be taken into account.

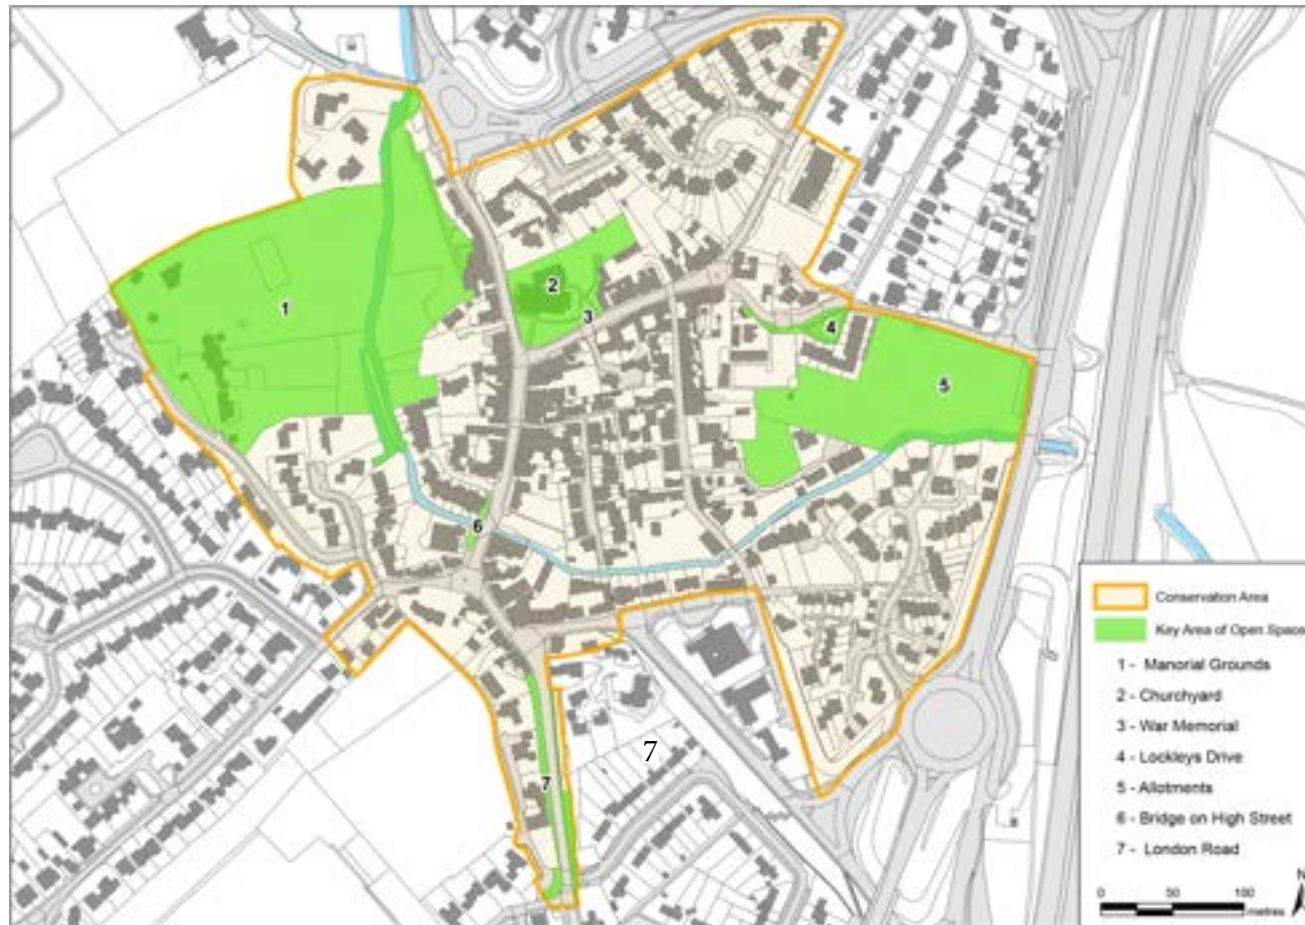
Figure 16 Key Open Spaces

There are several key areas of green space within the conservation area, shown on Figure 16. These make a positive contribution through their visual appeal, their contribution to the verdant character and setting of the village, and the communal value they bring.

The allotments (5 on Figure 16) have been identified as an area of Urban Open Land (UOL 12 on Welwyn Hatfield Policy Map, in relation to Policy no. SADM17). These are located within the heart of the conservation area, on low ground north of the River Mimram (Figure 13). The allotments form a large area of well-maintained land providing a key communal space for the village. There is value in the green space the allotments offer, creating a pleasant area from which views into the conservation area are varied and of interest due to the topography. To the west, they look onto the uniform backs of housing along Mill Road and the attractively irregular development and high red brick garden walls of Orchard Road. To the north and south, the sloping topography allows for views of streets, with staggered rooflines. This provides interesting views of rooflines and established planting on the brow of the hill to the south.

The churchyard of St Mary's Church is an area of positive green space in the core of the historic settlement (2 on Figure 16); the churchyard comprises of some mature trees, hedgerows and high quality street furniture. This is also reflected in the War Memorial, located to the south of the churchyard and enclosed by maintained hedgerows (3 on Figure 16). These areas provide key areas of public realm of communal and historical value to the village.

Throughout the conservation area there are also frequent areas of green space in the form of verges and planted banks, particularly along London Road (7 on Figure 16) and Lockleys Drive (4 on Figure 16). These areas of green space and planting contribute to a varied, verdant street scape.

The area surrounding the bridge on the High Street is also notable as a pleasant area of public realm, which reveals the river as a key feature of the conservation area (6 on Figure 16). Benches allow for visitors to appreciate the water's edge, which is fairly concealed by the built environment otherwise, and a bust of Vincent Van Gogh celebrates the village's association with the family through his sister, Anna (Figure 18). Vincent Van Gogh visited the school his sister taught at, now the listed Ivy Cottage on the High Street (List Entry No. 1100963).

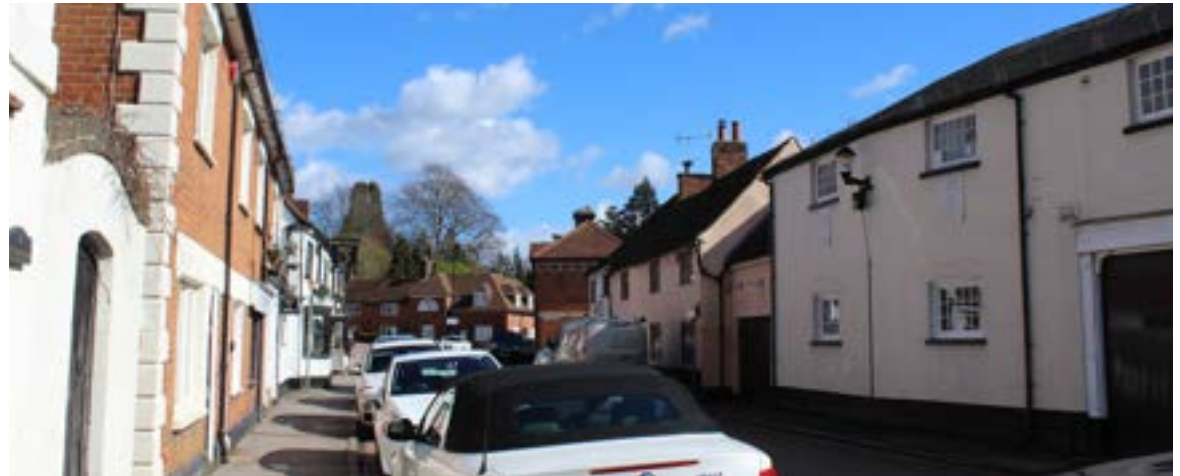
Figure 20 View east along Church Street highlighting variety of building materials and features

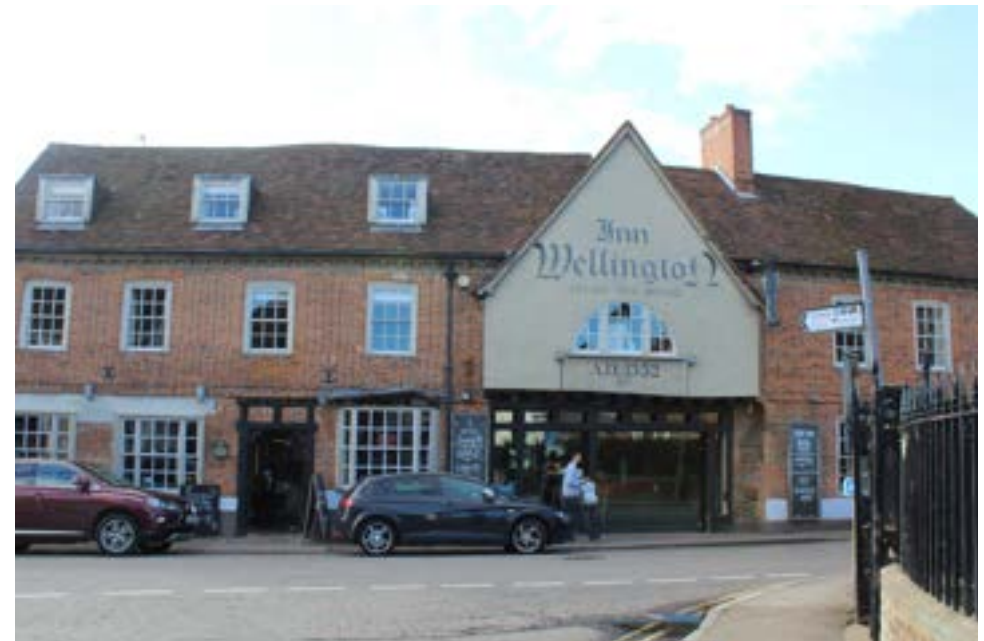
Figure 31 The Wellington Inn and Hotel

To the west, The Wellington Inn Hotel (List Entry No. 1348186) is a prominent, early seventeenth century timber framed public house with a red brick frontage and a rendered jettied gable with semi-circular window to the centre under a plain tiled roof (Figure 28).

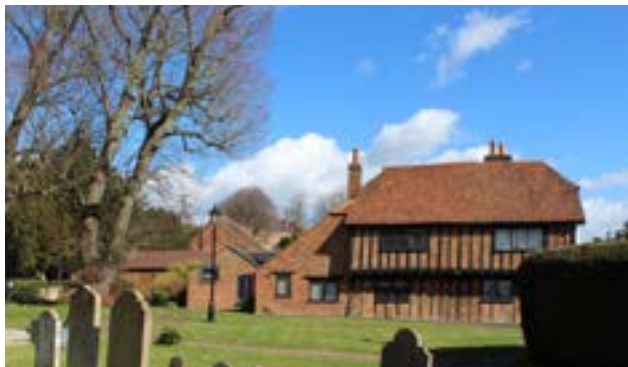
Figure 32 Church House from within the Churchyard

To the north of Church Street, adjacent to the church, is Old Church House (List Entry No. 1174994). Dating to the sixteenth century this timber framed, two storey building has an elevation to the churchyard with red brick nogging and a deeply jettied upper floor (Figure 31). It is rendered with a plain tile half hipped roof.

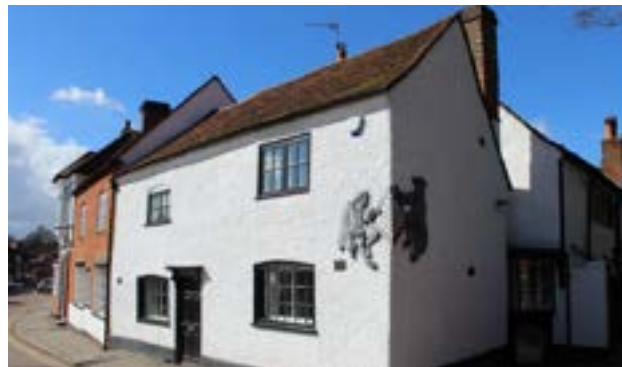
Figure 33 Wall art on the Old Chequers

Entry No. 1348200). The final building within the historic core of Church Street is no. 28, The Old Chequers, which is formerly a seventeenth century inn with potentially earlier origins (List Entry No. 1175014). The house is timber framed with a gable end front range in brick with roughcast render, with interesting detailing to the south east corner (Figure 33).

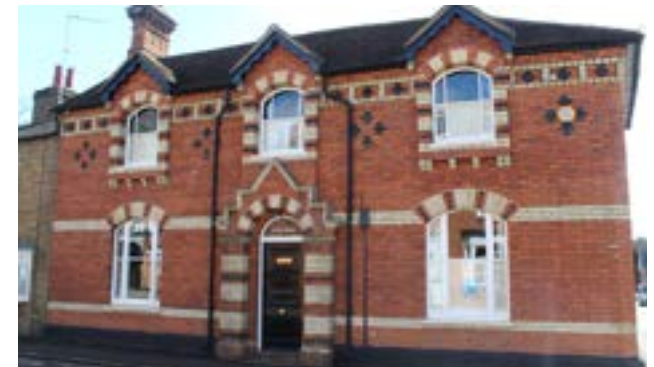
Figure 34 Gothic House, Church Street

The Gothic House (Figure 34), located on Church Street, makes a positive contribution to the character of the area due to its striking polychromatic brickwork with gault brick banding and striped door surround and window jambs and heads, typical of Victorian architecture but unique to the area.

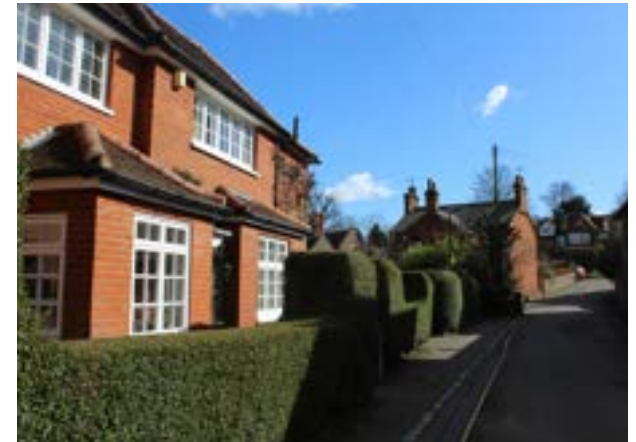
Figure 38 Boundary treatment at south of Mill Lane

On entering Mill Lane from the north, the Vineyard forms a striking row of well-preserved cottages (List Entry No. 1100936); it includes no. 8-14 and is Grade II listed. Dating from 1821, the houses are built of yellow stock brick with a low slate roof and two storeys in height (Figure 38).

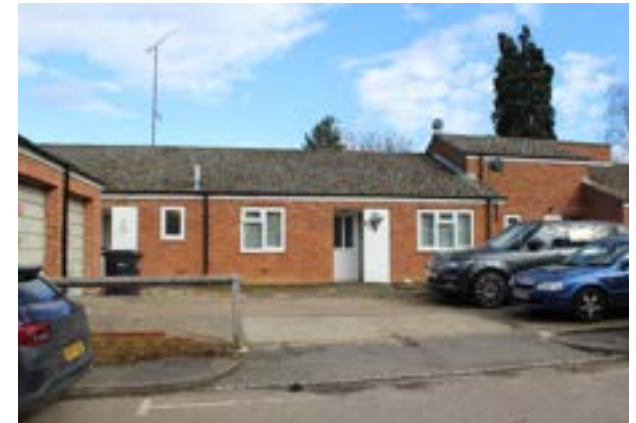
Figure 40 South of Mimram Place

The north side of Mimram Place continues this pattern, with properties either fronting straight onto pavements or retaining a strong boundary treatment where set back. To the south, however, the frontages of modern largely provide parking areas and detract from the streetscape (Figure 40).

To the south of Mimram Place, building materials which are unusual to the character and wider conservation area can be found. These include weatherboarding, concrete roof tiles, and a higher number of plastic windows.

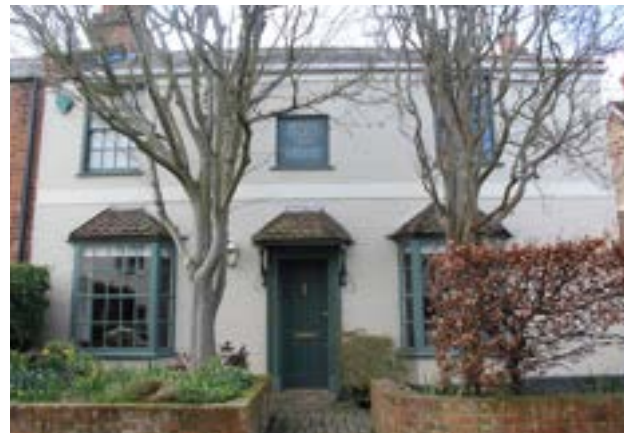
Figure 44 Bethel Lodge, Mill Lane

Other buildings and structures that make an important architectural or historic contribution to the street scene 5 Mill Lane makes a positive contribution to the area; it is a simple cottage, classically proportioned and symmetrical in design with fish scale tiled canopies over ground floor bay windows and the central front door, set behind a well-kept and planted front garden. The inscription on the façade of the house reads 'Bethel Lodge 1815' with a Latin phrase below *Dominus custodiat introitum tuum et exitum tuum*, translating to 'The Lord preserve thy going out and thy coming in' (Figure 44).

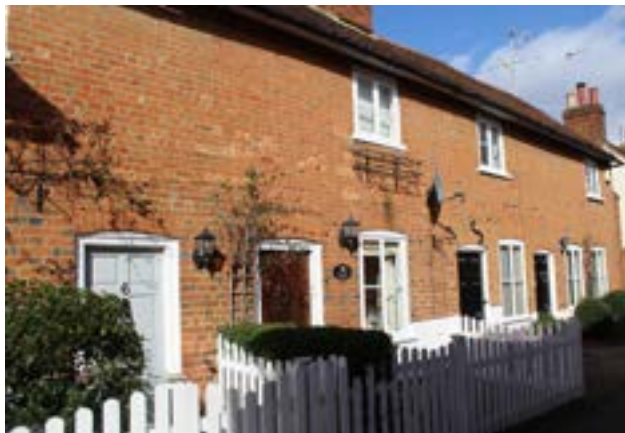
Figure 43 6-12, Mimram Road

Along Mimram Road is No. 6-12 Mimram Road (Figure 43). This grade II listed eighteenth century terrace is of timber framed construction with a red brick frontage and a rendered plinth to window sill height.

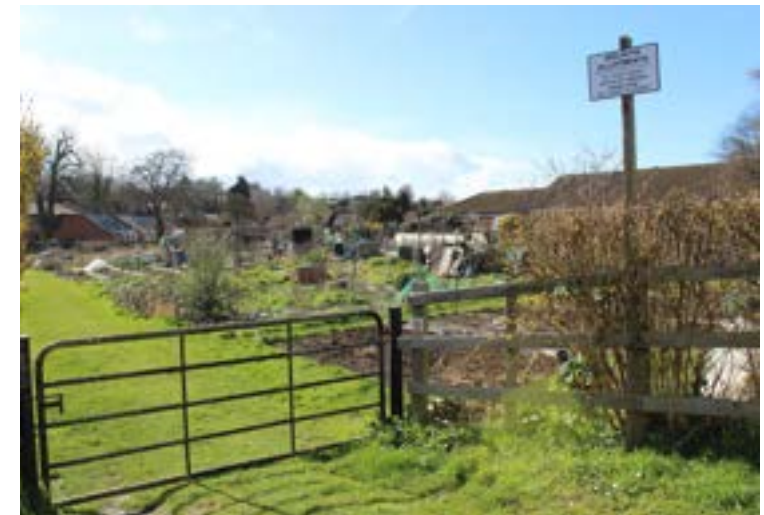
There are few formal boundaries within the area, due to the fact that it is dominated by open space and allotments (Figure 47). However, where there is development, it is often bounded by hedgerows and permeable timber fencing, which is rural in character.

Figure 47 Boundary of the allotments

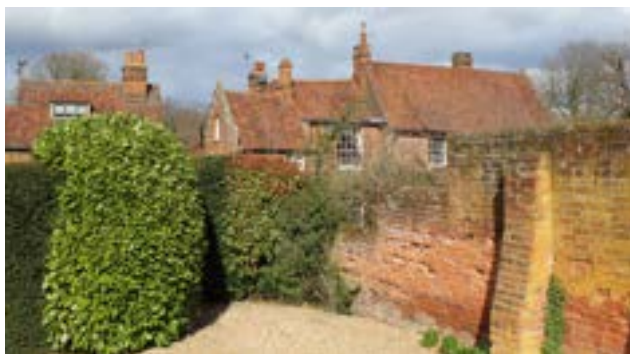
Figure 54 Parkside and Appletrees

Further east along Prospect Place, a row of red brick workers' cottages makes a positive contribution to the street scene. The streetscape alters further east, as dwellings become larger and set within substantial private gardens, enclosing them from the street front (Figure 54).

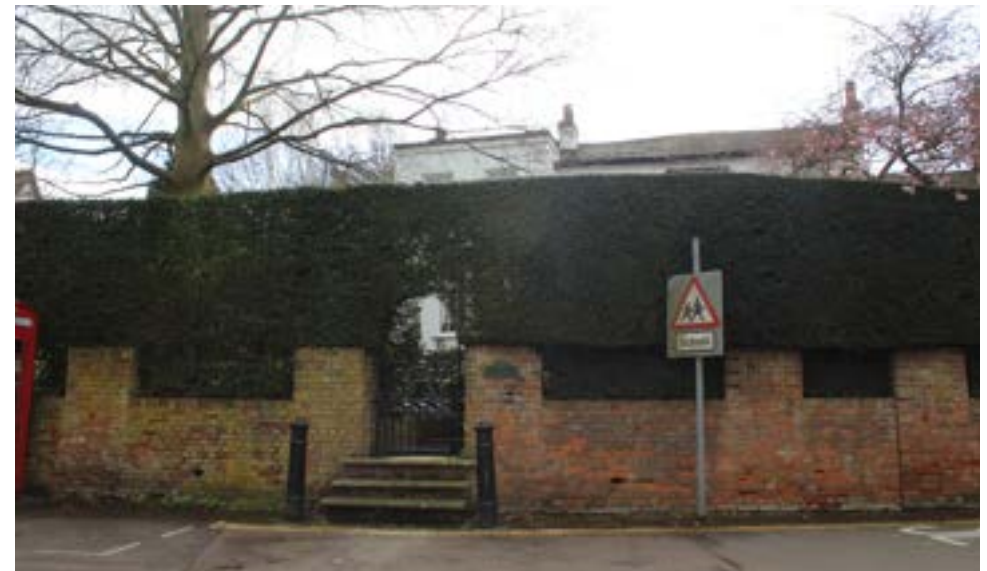
Figure 55 Boundary of the White House

The larger plots in this area provide room for strong and extensive boundary treatments. Consistent with the wider conservation area, boundaries are typically formed either by buildings themselves which front the street, by red brick walls or hedgerows (Figure 55). These high brick walls and manicured hedges, particularly on the east of Prospect Place and along the south side of School Lane (Figure 55), contribute to the character of the area by creating a prominent and grand front to the larger buildings located here.

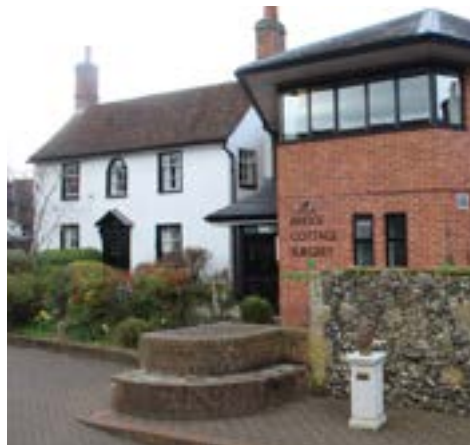
Figure 56 Grade II listed Surgery

Crossing the River Mimram to the south, four grade II listed buildings cluster around the southern junction of the High Street with London Road. South of the river to the west is the surgery, Figure 56 (List Entry No. 1348187). This former house comprises an eighteenth century rendered frontage with an earlier timber framed core and a modern two storey canted extension.

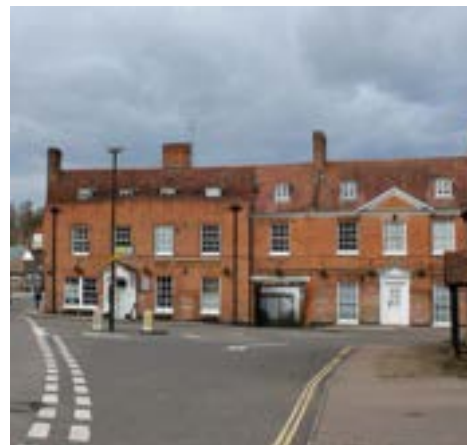
Figure 58 The White Hart and Number 4

Following London Road to the south, there are a number of listed buildings at the junction with Prospect Place. To the north of the junction, The White Hart forms the corner (List Entry No. 1100941); the grade II listed inn dates to the mid eighteenth century with a rear wing. It is constructed partly of timber framing with red brick frontage containing vitrified headers and some roughcast render (Figure 58).

Returning to London Road, Number 4 comprises a brick house with burnt headers dating to 1729, with a plain tile, double pile roof (List Entry No. 1295405). Along the western edge of London Road to the south is Little Chequers, a grade II listed building which dates to the eighteenth century (List Entry No. 1348188). The house is two storeys and constructed of chequered red brick with a steep plain tile roof.

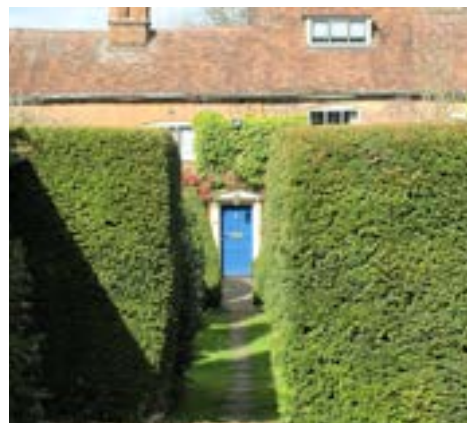
Figure 59 Appletrees

Along Prospect Place are two grade II listed buildings, Appletrees (List Entry No. 1175315) and Parkside (List Entry No. 1348192). Formerly cottages, Appletrees dates to the late sixteenth century and is constructed of timber frame cased in eighteenth century brick (Figure 59).

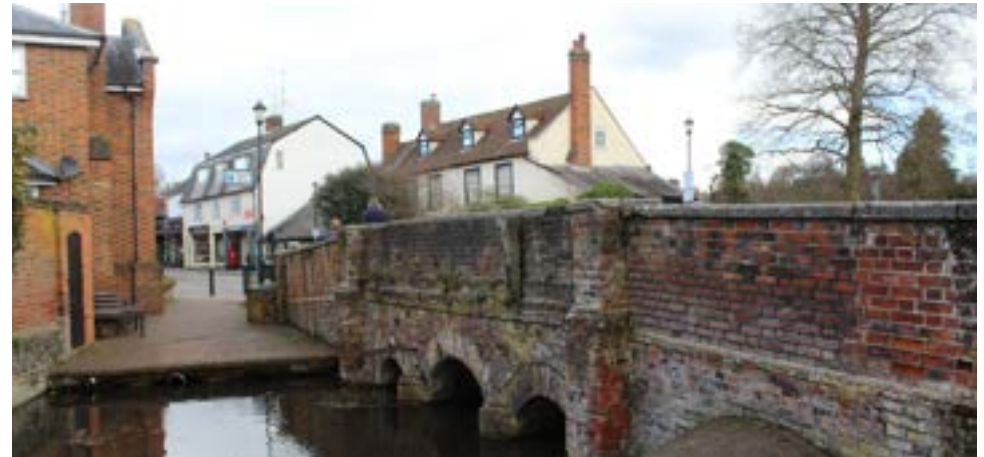
Figure 60 The Bridge

The bridge forms a key feature within the character area (Figure 60). The red brick structure with three arches crosses the River Mimram to the north of the area, providing a point for views to the west and east and forming a focal point itself, marking the entrance into the village centre.

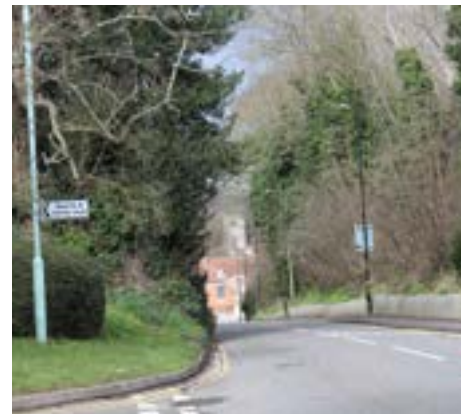
Figure 61 View north along London Road

The planting on London Road is also important in signifying the entrance to the village, creating a green passage down the valley and towards the church tower and village core (Figure 61). This planting predominantly comprises of unkempt shrubs and overhanging trees, creating a dense and enclosed character.

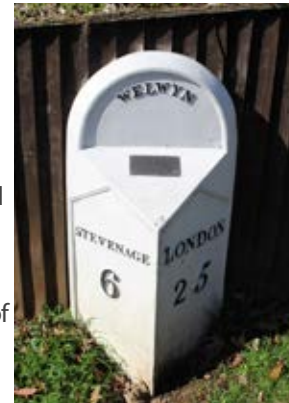
Figure 66 Listed Milepost on Church Street

Located along Church Street to the south of the entrance into the Welwyn Hall Gardens development, is a Grade II listed milepost (List Entry No. 1100958). It is a mid-nineteenth century cast iron milepost manufactured by Champness of Cheshunt. It is triangular in plan with a semi-circular top with 'Welwyn' in raised letters. The two front faces have recessed panels with raised numbers and lettering reading: London 25, Stevenage 6.

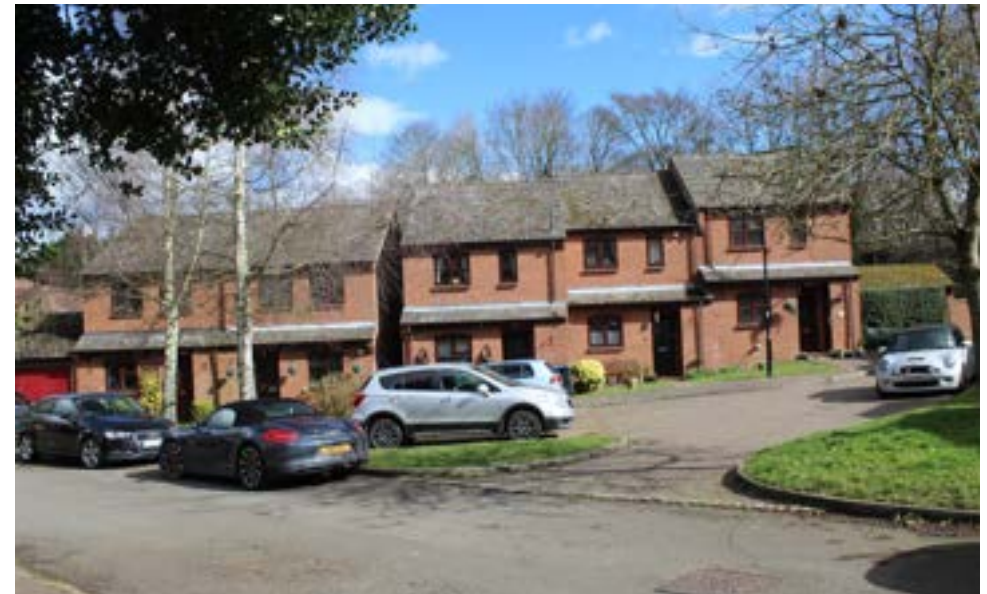
Figure 68 Houses on Parkside

The removal of the Parkside housing estate could be beneficial in better preserving the historic character of the area. The housing development is separate in its character and development pattern and does not respond to its surroundings but rather creates its own modern character. Although neutral in its contribution to the conservation area, it is lacking in historic and architectural special interest.

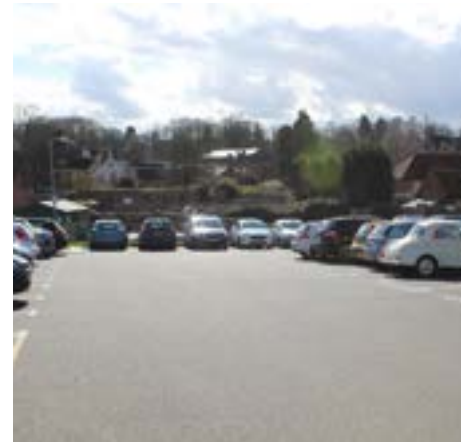
Figure 69 Lockleys Drive Parking

Car-parking is an inevitable concern within any historic village settlement, and the same is true for areas of the Welwyn Conservation Area. Overall, ample parking space is provided for the village, with large parking areas on Lockleys Drive (Figure 69) and the High Street (Figure 70).

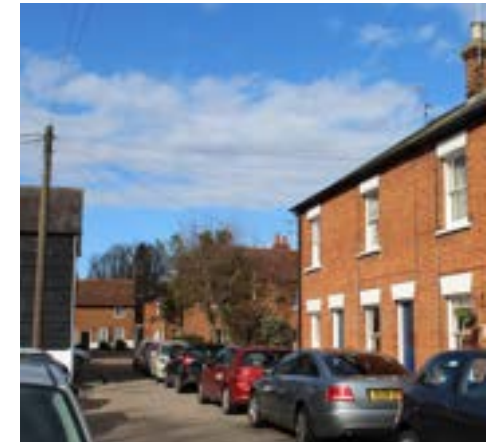
Figure 71 Parking on Mimram Road

Along Mimram Road, however, parking makes a negative impact on the character of the area as the road is narrow and parking on street can make access difficult (Figure 71). The rear entrance to Tesco is paved here for parking, and there is opportunity to enhance this space to integrate it with its surroundings. The paved area to the south of Mimram Road, which is currently used for private parking, would benefit from a consistent hard surfacing, planting, and sympathetic boundary treatment to soften its impact, which is currently a modern metal railing.

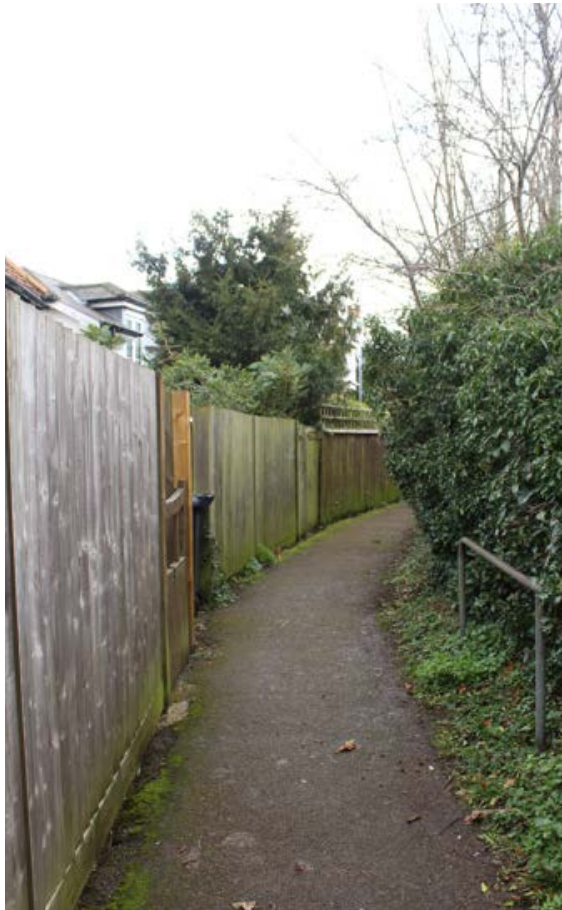
Figure 72 High fencing on Halls Close

It is also considered that some boundary treatments are currently out of keeping with the character of the area. High, close boarded fencing and chrome metal railings should be replaced with permeable timber fencing, hedgerows, red brick walls, iron railings or low close boarded fencing where possible. This will ensure the boundary treatments make a positive contribution to the area as well as improving intervisibility within the area (Figure 72).

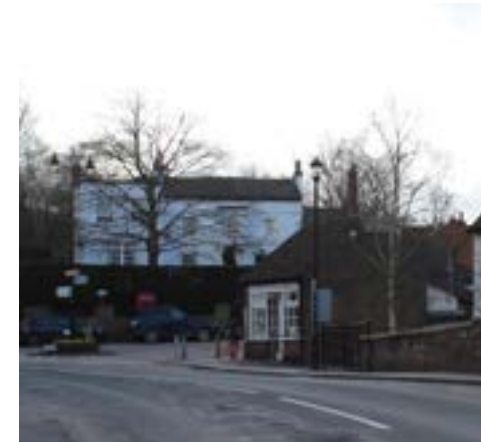
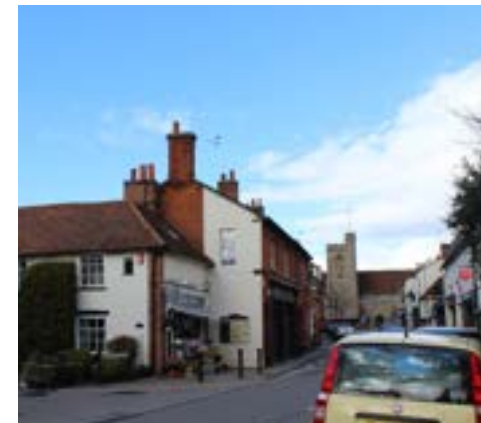
The conservation area contains several areas of public realm, which include street furniture such as benches and bins. The area would, however, be enhanced through a consistent approach to the design of lampposts and bollards, particularly along the High Street, where multiple styles can be seen within one vista. Figure 74, for example, shows the concrete bollards at the junction of School Lane and the High Street, while Figure 75 depicts more historically characteristic iron bollards.
